Manhole Inspection Summary

Manhole # S13A__009MH

Location Address: **719 RAYNER AVE** Cross Street: **POPLAR GROVE ST**

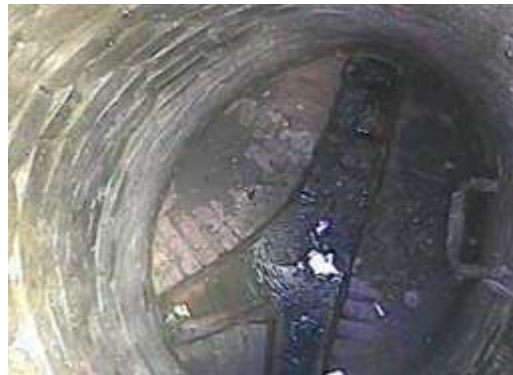
Defect 1

Steps Count: **1** Missing: **2** ☒ **Corroded**

CORRODED STEPS

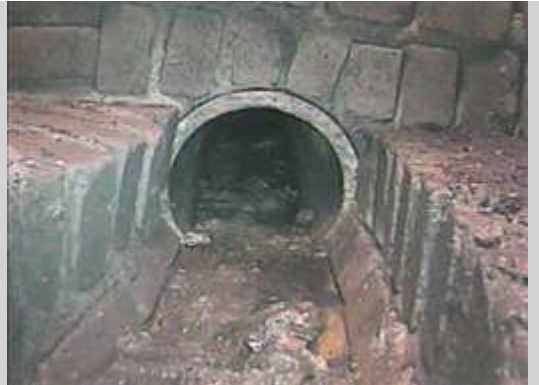
12 O'Clock Outflow

8 in. Circular Gravity Sewer
Pipe Out @ 12 O'Clock

Pipe Height: (in.) Direct
Pipe Material: **Clay** ☐ Pipe Lined
Invert Depth: **7.36** (ft.) Flow Characteristics: **Slow**
Deposits: ☐ None ☐ Mud ☒ **Sludge** ☐ Debris ☐ Grease
Silt Depth: **1** (in.) Deposits Extent: **Light**
Infiltration: **None** Pipe Seal Cond: **Sound**

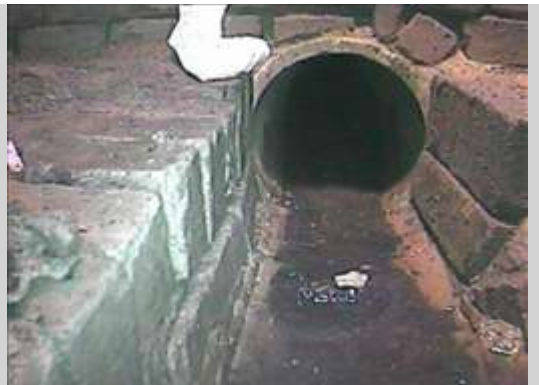
6 O'Clock Inflow

8 in. Circular Gravity Sewer
Pipe In @ 6 O'Clock

Pipe Height: (in.) Direct
Pipe Material: **Clay** ☐ Pipe Lined
Invert Depth: **7.18** (ft.) Flow Characteristics: **Slow**
Deposits: ☒ **None** ☐ Mud ☐ Sludge ☐ Debris ☐ Grease
Silt Depth: (in.) Deposits Extent:
Infiltration: **None** Pipe Seal Cond: **Sound**

Connects To: **Stub connection / abandoned**

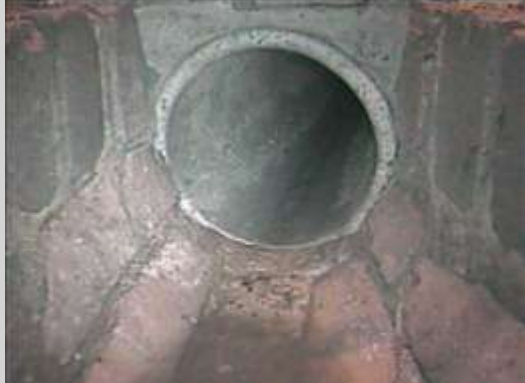
7 O'Clock Inflow

8 in. Circular Gravity Sewer

Pipe In @ 7 O'Clock

Invert Depth: **7.20** (ft.) Flow Characteristics: **None**

Connects To: **House connection / Service line**
